Algonquin to Adirondack Conservation Association

**Analyzing the Resistance Values of the 401 Highway to Wildlife Movements
in the Thousand Islands Section of the Algonquin to Adirondack Corridor
and Thousand Islands Frontenac Arch Biosphere Reserve**

conducted and prepared by
Don Ross
Science Coordinator
Thousand Islands - Frontenac Arch Biosphere Reserve

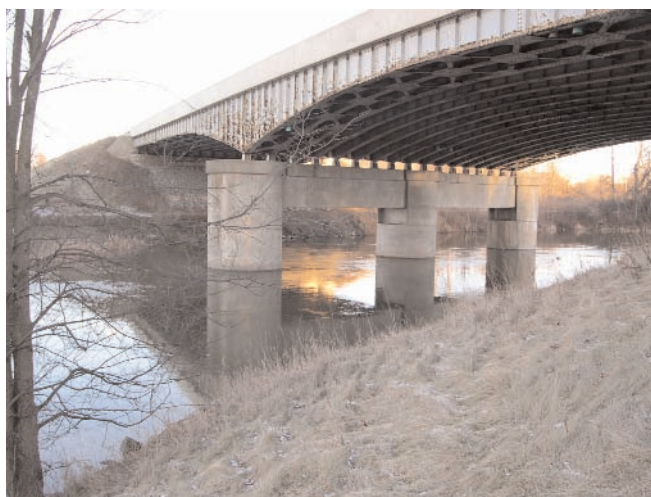
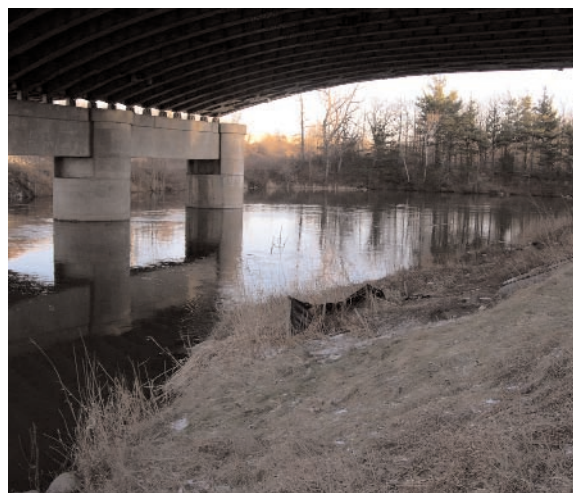
Gananoque River bridge. While the highway segment here has low value, because the surface is virtually inaccessible from north or south, the underpass value is High. The bridge was visited on a number of occasions from December to late May. From track evidence under the bridge, in sand and snow, there is light but regular traffic by deer, coyotes, raccoon, fox, weasel and meadow voles; and muskrats and beaver were seen in the water. (note: more detail presented in Gananoque River Corridor Section)

Gananoque River Bridge; west side as seen from north side Animal paths follow water's edge

Wildlife use of the underpass on this side of the bridge is light, but regular. Tracks of deer, coyote, fox, raccoon, mink and/or weasel are found in the snow and sand. The tracks for the most part stay closer to the water s

edge under the bridge, and approach from north and south through screening provided by the shrub cover. The approach paths are well-worn, and obviously traditional. The path under the bridge is less well defined, and animals use both the bank at and in the water, apparently staying as far below the overhead works as possible. There was, however, no road kill, even very old remnants, within several hundred metres of the bridge, suggesting the route is well established. There are no other mammal passages along this section of the 401.

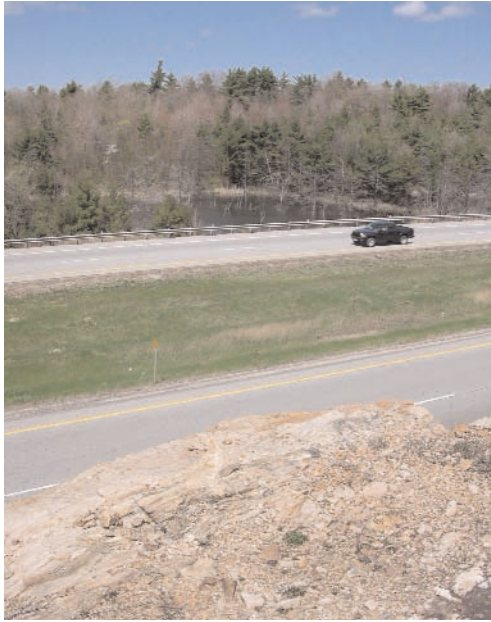
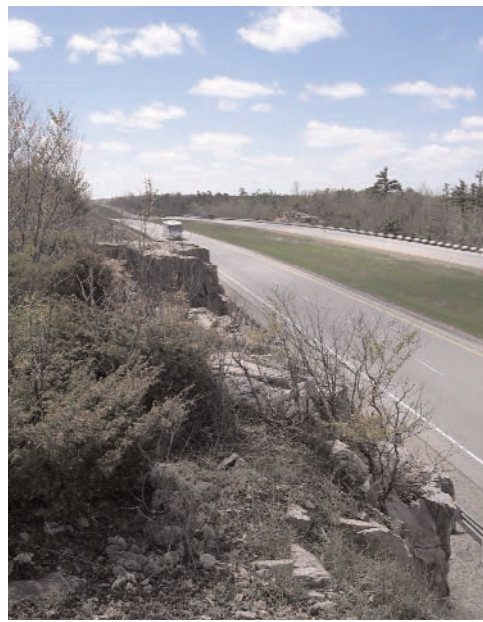
Fitzsimmons Mountain area. The private and public lands on the south side of the Highway 401 in this area are known for their ecological diversity, and are a designated Area of Natural and Scientific Interest (ANSI). The lands directly across the north side of the 401 at this area have lesser ecological value, and the corridor linkages would seem, from map exercises, to tend east-west here. Even so, this particular area has notable wildlife mortality. However, because of the character of the terrain, the road bed is substantially elevated above grade where valleys have been rock-filled, or in other places blasted through ridges leaving deep rock cuts. In several places, there may be above grade, rock-fill portions south and rock cuts north, or vice-versa. The rock cut funnel effect discussed above comes into play here, focusing locations of road kill.

Two views of highway typical at 401 north of Landons Bay - Fitzsimmons Mountain

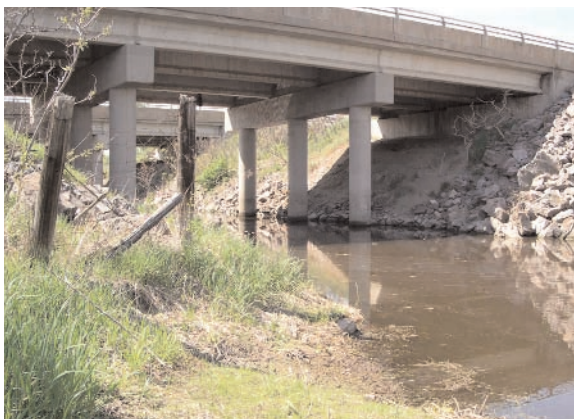
LaRue Creek bridge. On the spring day when the LaRue Creek bridge was valued, there were surprisingly few tracks of animals of all kinds in the mud to the north and south of the bridge. Perhaps the fact that there is no terrestrial component, no land to walk on, under the bridge might mean that animals were not inclined to use this wide underpass. In winter, however, when ice was in, there many tracks of deer, coyote and fox on a number of occasions. It would appear that the bridge is a better conduit in winter than the remainder of the year, but perhaps this could be changed by adding a terrestrial area under one or both sides of the bridge, leaving ample volume for water flow in spring runoff.

LaRue Bridge, looking north: lacks terrestrial passage

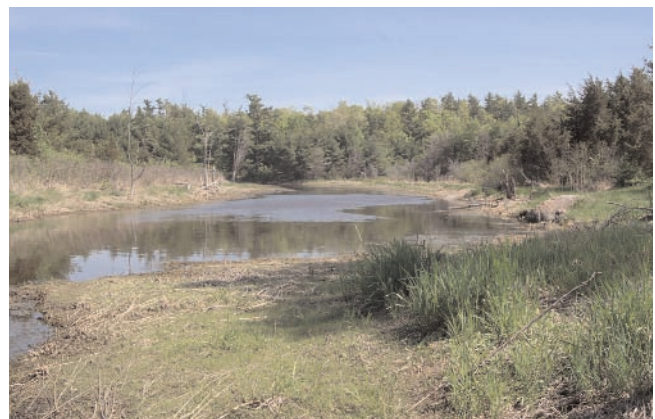
LaRue Creek, looking south

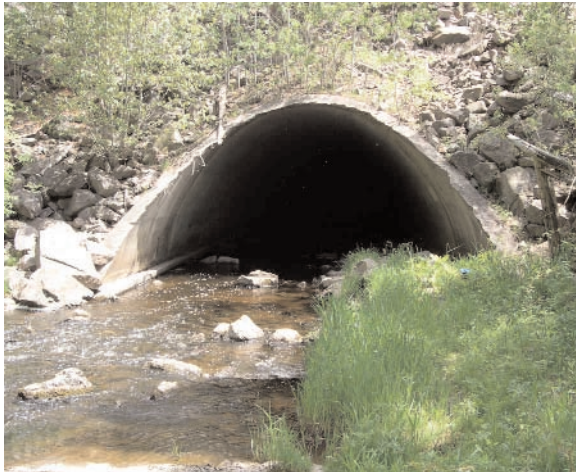
Jones Creek. Jones Creek passes under the 401 at Yonges Mills, where there was at one time a waterfall, and grist mill. The underpass structure for the creek is an arch-shaped tunnel. The flow of the creek is still brisk through the tunnel, and there rapids in the tunnel. Well-used animal tracks of deer and coyote, and likely others, approach the tunnel from the north, but it is unclear whether they use the passage or are merely guided to it after following the creek valley. The noise of the rushing water, the darkness inside, and the rock and boulder-strewn creek bottom with deeper pools seem intimidating, at least from a human standpoint. However, inside the tunnel, running along both sides, there is a narrow (20 — 25 cm wide) ledge in the cement which forms a walkway end to end in the tunnel. As the concrete roof of the tunnel arches over the ledge, there is not much vertical clearance for passage by tall animals. Along the ledge, though, there is occasional scat of otter and raccoon, and droppings of bats. A wider ledge, soft-surfaced, may be incentive for more use by a broader range of species, as the creek valley seems to funnel traffic to the tunnel area.

Jones Creek tunnel, from north side

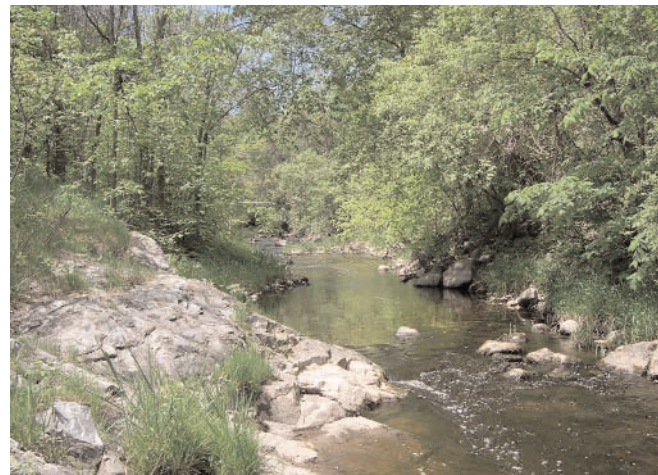
Jones Creek, looking north

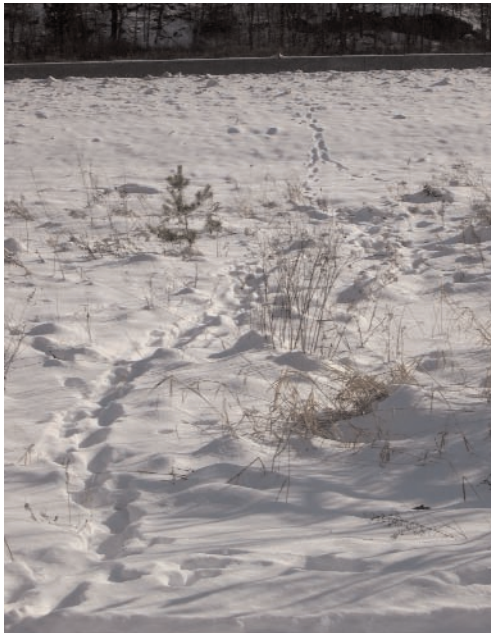
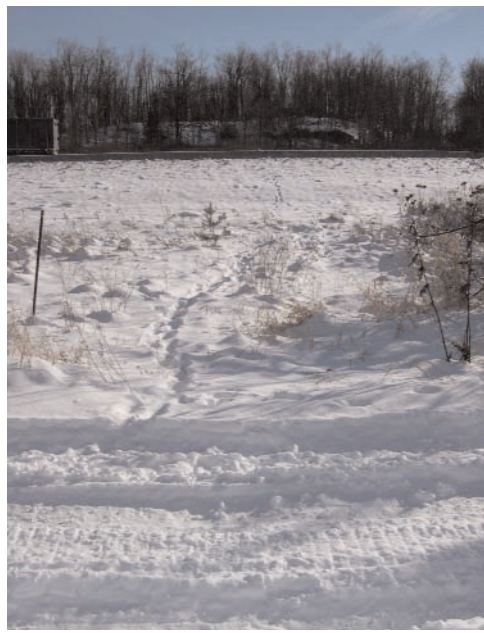
Hesitation Marks. Some of the extensive ski and hiking travel was through the Gananoque Wildlife Preserve, from the Leeds County line to the Gananoque River, and inland in places up marsh bays and beaver ponds. The snow cover was very helpful in understanding animal movements. Of note is that wherever there are low-lying areas near the 401 with good dense cover of dogwoods etc there are numbers of hesitation marks where deer, fox, coyote, weasel, rabbits, mice approach the highway area, up to the fences, several times, and even up to the road itself, and turn back in almost all cases (track stories). There are several places where the fence is bent down or pushed open from animals crossing. One deer carcass was found; 1.5 km west of the Gananoque River, near the highway: it was hit but ran from the roadway, where it died and was later eaten by coyotes. The observation of interest is the hesitation marks, showing desire but trepidation over crossing the highway. Such observations were made many times in the winter exploration part of the study, at many locations. The scenario is likely oft-repeated in all seasons of the year.

Hesitation marks - many species of animals approach the highway several times before attempting or abandoning the crossing

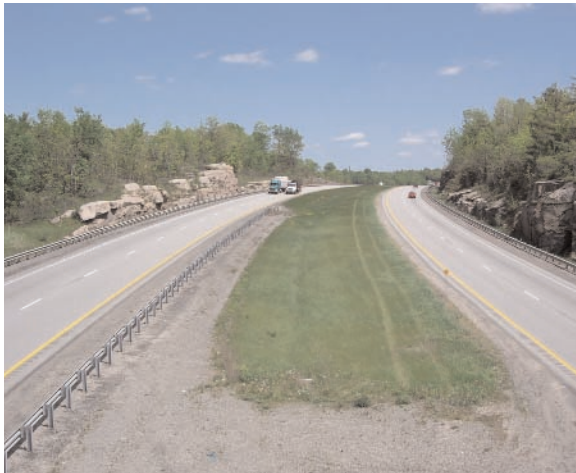
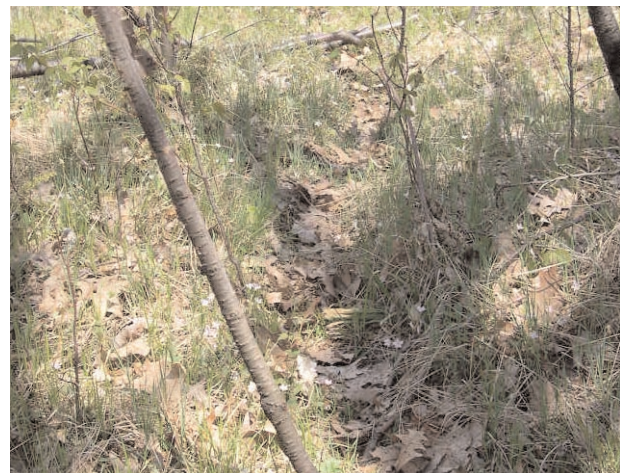
Funnel Effect. Perhaps one of the most valuable findings from the study is a funnel effect of the landscape. This is an effect where the topography funnels meandering mammals to segments of the highway.

As suspected, when the highway runs through rock cuts, there are not often road kills found. The drop-off seems to discourage crossings. However, those rock cuts are from rock ridges that were cut through when the roadbed was being laid. The rock ridges have poor or shallow soil, and most often in this area remain or have again become forested. Animals may be channeled to segments of the highway along these forested ridges. Many of these were explored, to look for established animal trackways, and many such trackways were found leading to the top of rock cuts. At the rock cuts, the paths turn parallel to the highway, as animals presumably follow the top of the rock cuts looking for a way down to lower levels, and opportunity for highway crossing.

Funnel effect - trails like those at right lead atop rock cuts to places where rock cut drops to grade level, especially at the downstream end. Animals are lead by the topography to these crossing points

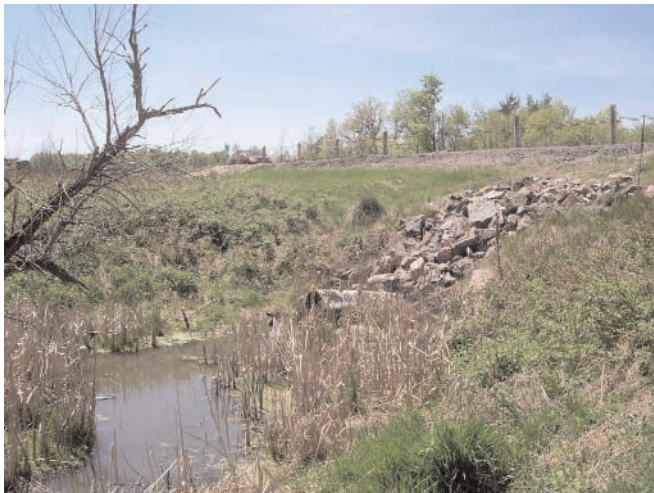
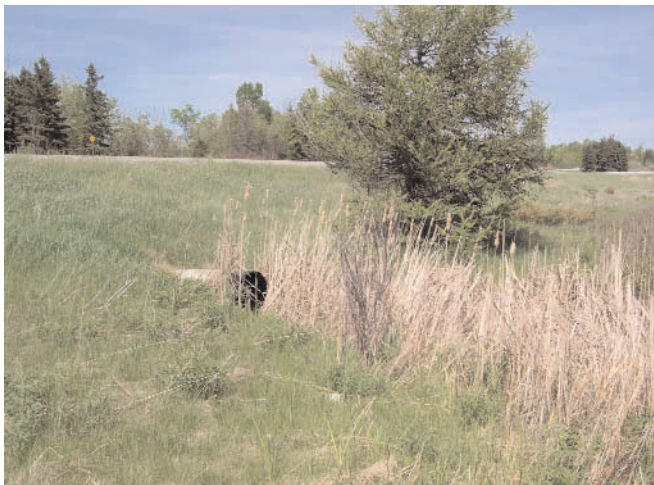
Approach restoration. Existing culverts are drainage-oriented, with streams and wetlands ditched near the highway to ensure waterflow. The ditches are seldom similar in character to the wetlands the drain, or drain towards. Reconnection of habitats through the use of underpass structures would require the restoration of habitat from wetlands to culvert entrances. This would have to be done so as not to diminish the capacity of the drainage works.

Two culverts of the same size are pictured. The top picture shows a culvert with better potential for improvement than the one below.

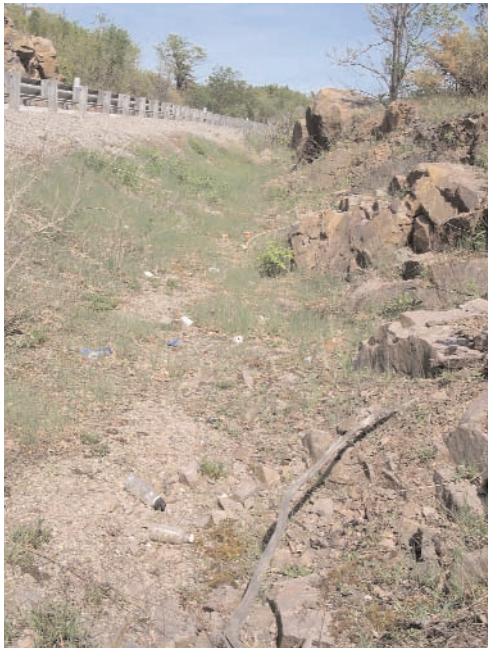
Litter. The quantity of trash and refuse along the shoulders and right of way is staggering. It is literally possible to walk the length of the road stepping from plastic bottle to plastic bottle. Plastic drink bottles have replaced the styrofoam cups as the number two item on the roadside. Many are half full of the most vile smelling liquid you could imagine, as if there were no rest stops from Toronto to Montreal. The most common item is fragments of tires — rusting wire and rubber chunks that are truly a solid band along the shoulders. There are work gloves every few metres, blow out of the backs of trucks, socks, tarpaulins, pieces of wrecked furniture, shoes, underwear, Tim Hortons cups, glass bottles, books, bottle caps, fast food wrappers, stir sticks, paint cans, hub caps, license plates, bungee cords, windshield wipers, paper bags, plastic bags, mattresses, sweat pants, cds, cassette tape and virtually anything one could ever imagine. The roadside is a minefield of litter and wreckage.

Typical amount of litter along the side of the 401 Highway
